Introduction

Analysis

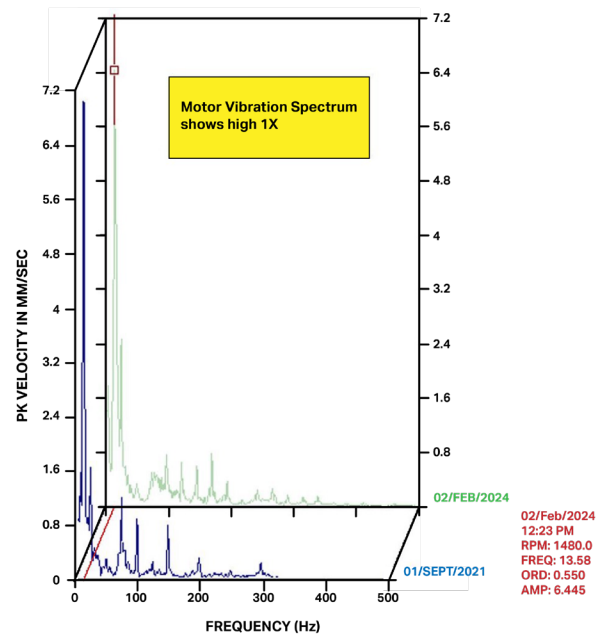
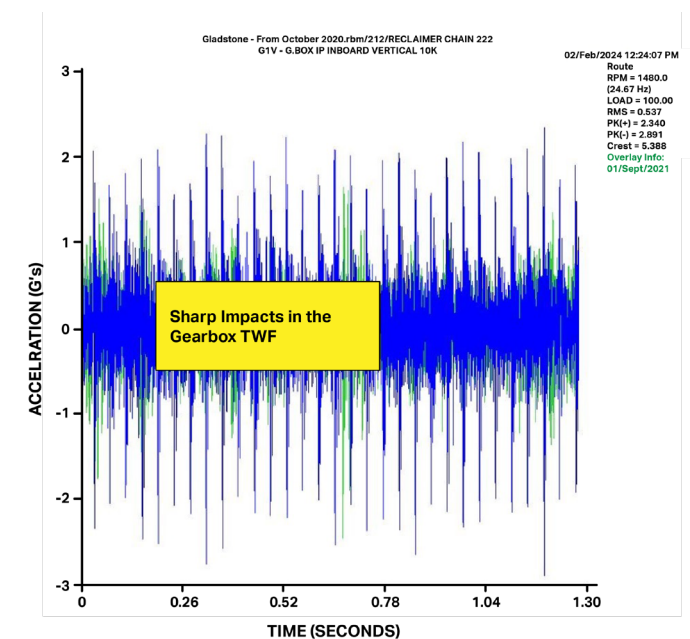
Data Collected by MDI

- » The motor shows acceptable but high (moderate) vibration levels according to the ISO Standards 20816-3 as per machine class and type.
- » The motor shows elevated vibration at the running speed component 1X (13.56 Hz) with an amplitude of (6.4 mm/s rms) indicative of a few causes such as structure looseness and excessive clearance.
- » The gearbox also shows elevated vibration at the running (input) speed, in addition to impacts on the TWF which could be an indication of internal damage in the gearbox.

As a result, MDI requested a borescope inspection to confirm the condition of the gearbox. Utilizing a borescope to validate some early warning signs allows technicians to identify defects, wear, or damage in inaccessible spaces without disassembling machinery or structures.

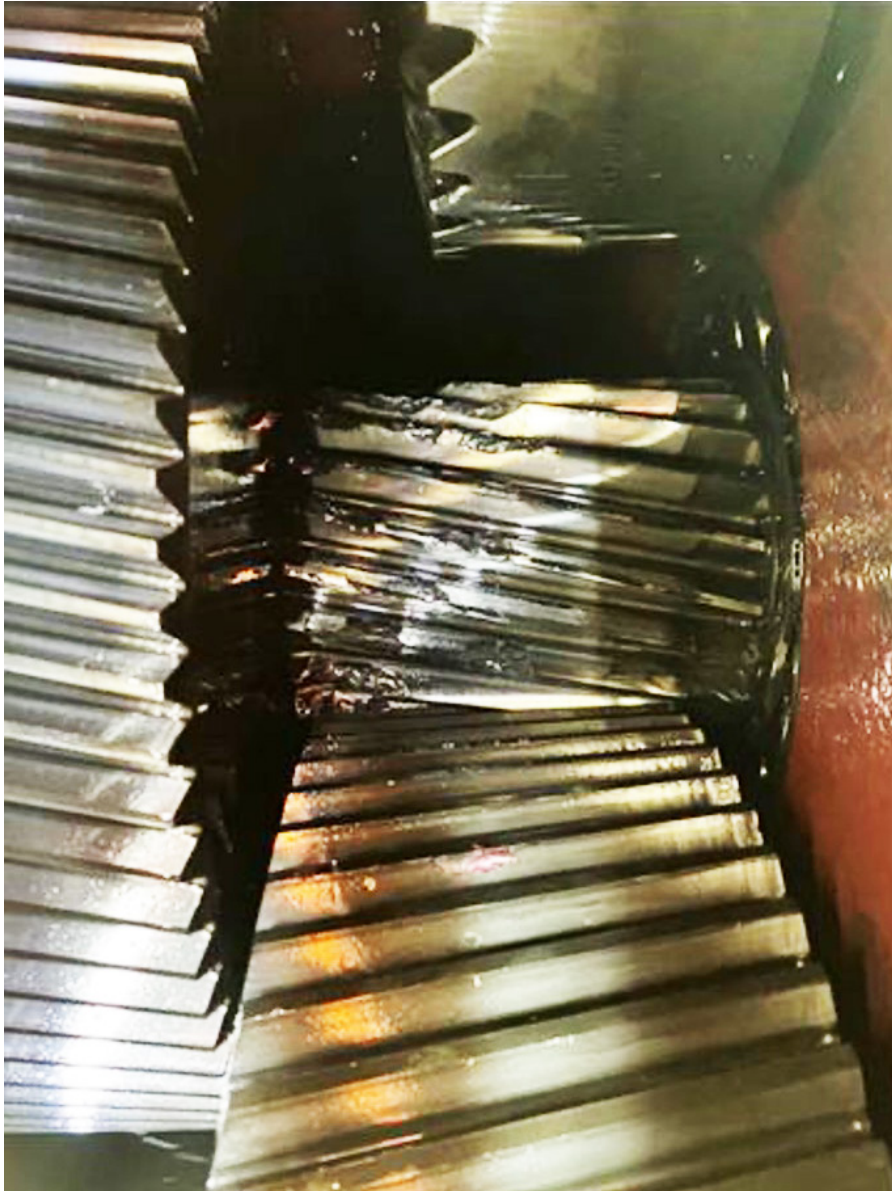
Following the borescope examination, damage consistent with the vibration data was validated as depicted in the photo to the left.
