## Introduction

Large commercial chillers are critical to facility operations, supplying thousands of tons of cooling through extensive piping networks. While the machines themselves are designed for reliability, the surrounding support structures may be more vulnerable. JetTech Mechanical was commissioned to perform routine vibration analysis at Arizona's State Farm Arena. The arena operates six chillers connected to a common chilled water header.

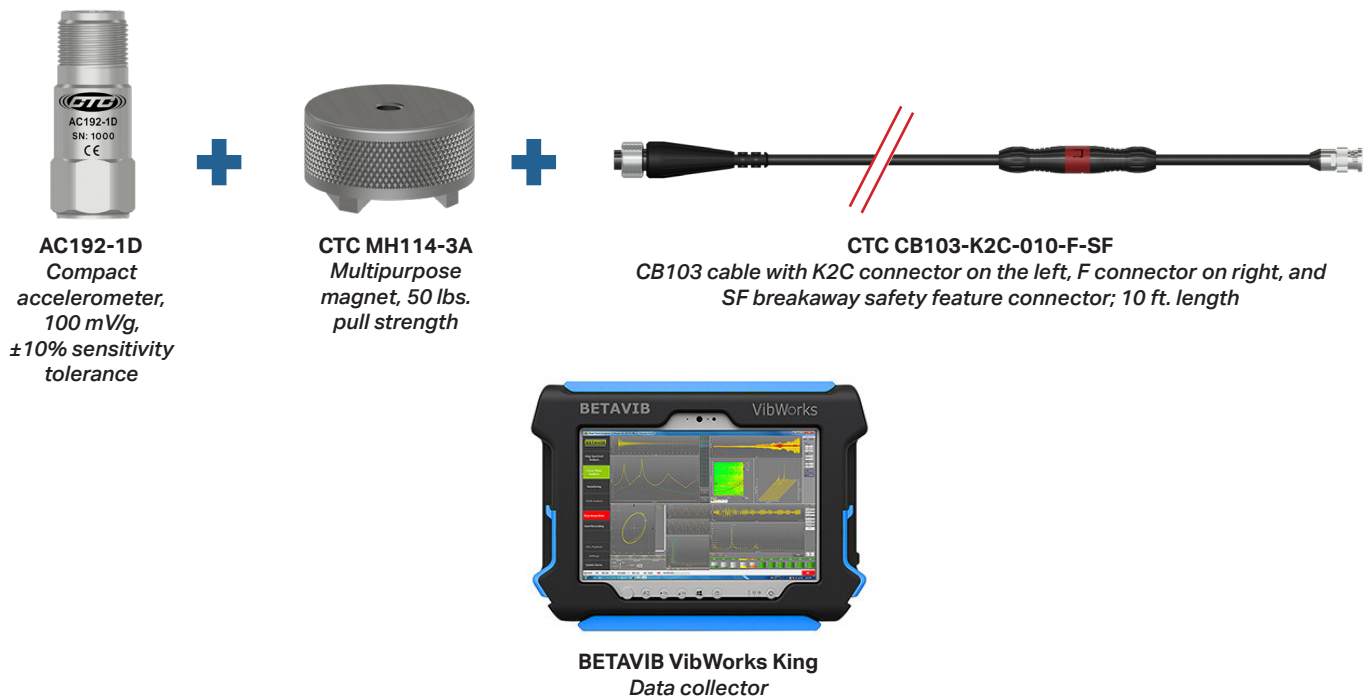
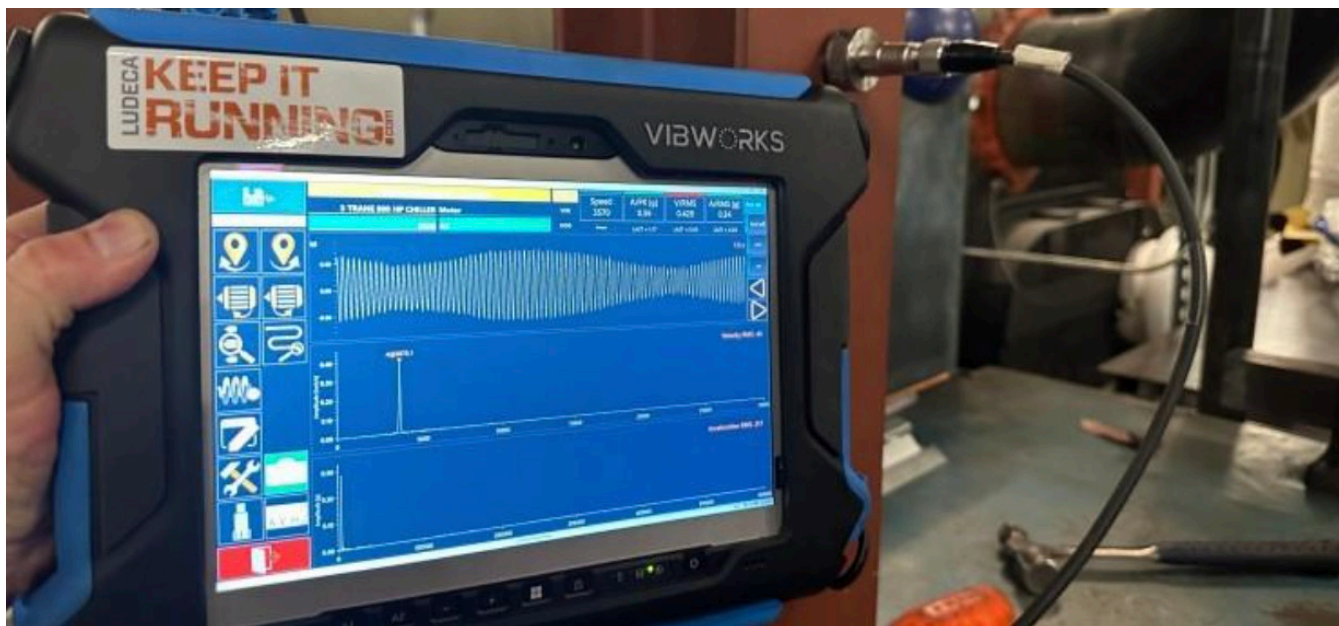
During routine vibration data collection, excessive vibration was detected - not on the chiller, but on the piping support structure. The newest unit, a **Trane 862 kW ( $\approx 1,156$  HP) chiller** operating at **4160 V and 3570 RPM**, was piped into the header alongside the existing chillers. The chilled water lines are supported on H-beam steel mounts. While the supports appeared substantial, vibration monitoring revealed otherwise.

The impact testing confirmed the cause: **structural resonance**. The results showed that the H-beam supports had a natural frequency of **~59 - 60 Hz**, nearly identical to the chiller motor's operating speed of **3570 RPM (59.5 Hz)**.

When the chiller was online, vibration at the top of the support frame reached about **0.7 in/sec peak at 1x running speed**. Amplitudes increased from bottom to top, showing that the structure was resonating in **its first bending mode**.

It was determined that resonance was exciting the piping support structure at the chiller's operating speed. While the chiller itself was unaffected, the facility faced significant structural risk if left uncorrected.

- » **Stiffening the support frame** with gussets, cross-bracing, or tie-backs to raise the natural frequency above ~75 HZ
- » **Adding damping** using constrained-layer materials or viscoelastic pads
- » **Installing a tuned mass damper (TMD)** near the frame top, tuned to ~60 Hz
- » **Isolating piping** with spring hangers or isolators (within nozzle load limits)
- » **Reducing excitation** through balance/alignment checks
