## Introduction

A gearbox defect was detected by MDI while on route in Queensland, Australia.

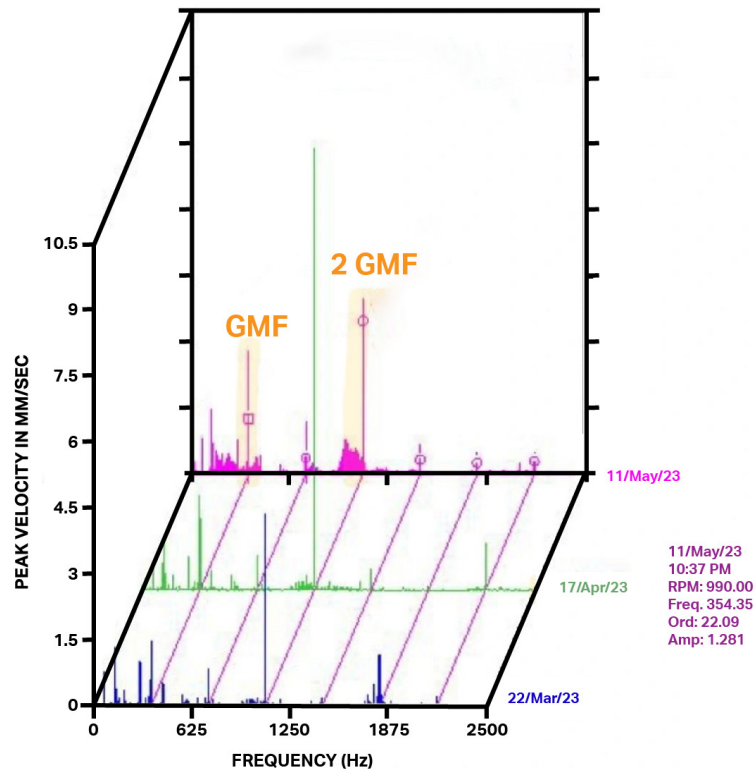
WATERFALL SPECTRUM

The data shows repeated impacts, which was confirmed through a borescope inspection.
