Introduction

Analysis

MDI was commissioned to perform routine data analysis at a Cement Plant. A gear mesh fault was found on a gearbox.

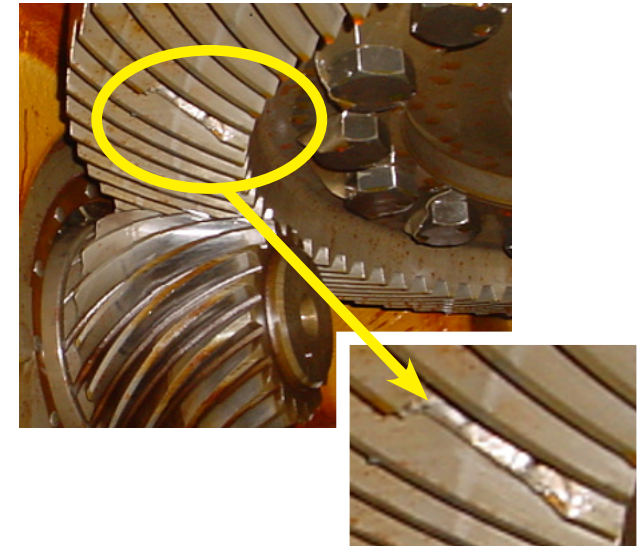
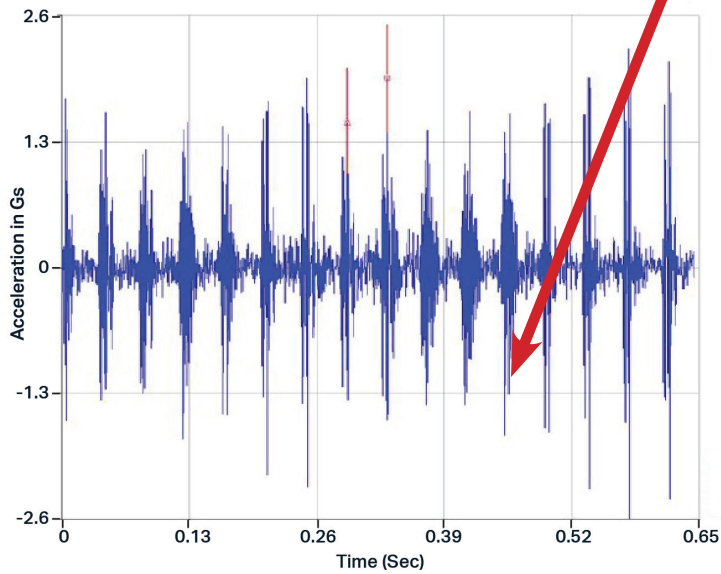
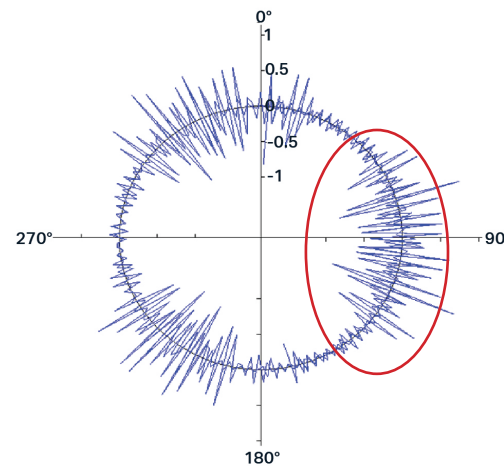
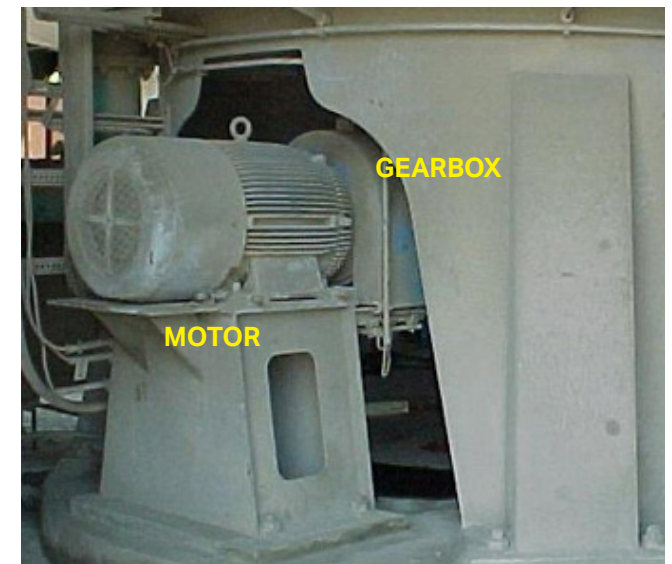
Gearbox bearing spectrum showing elevated vibration at the running speed with harmonics in addition to high amplitude impacting vibration at the time wave form at the running speed indicative of cracked or broken gear teeth

Through routine data collection, MDI was able to see that there was a clear gear mesh fault, which ended up being a chipped tooth. As a result, the recommendation was to replace the gear, prior to failure.
