### Introduction

A belt-pulley driven fan at a paper mill began exhibiting elevated vibration levels, particularly in the vertical axis. Initial assumptions pointed to bearing issues, and 1311 ETN9 self-aligning ball bearings were considered due to their tolerance for misalignment and shaft curvature. However, the root cause was not immediately clear.

Paper Mill / Belt-Pulley Driven Fan

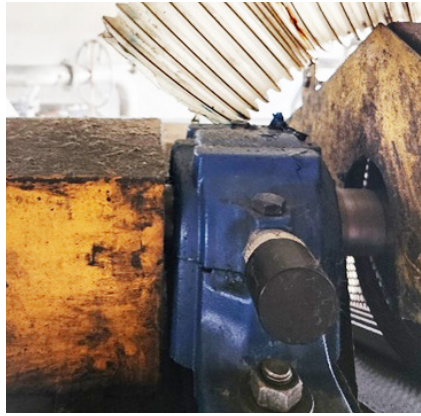
**Fig. 1**

*Triaxial vibration data was collected on an hourly basis from the pulley side bearing of this vacuum fan.*

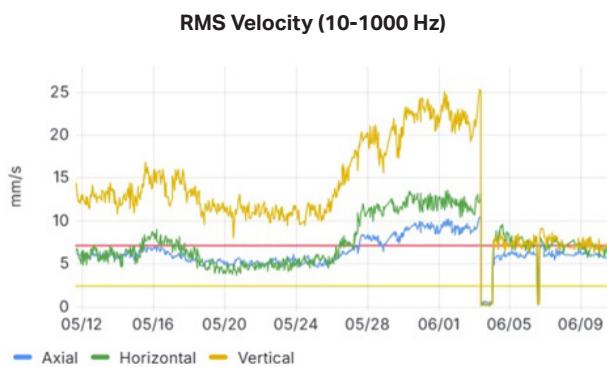
**Fig. 2**

*While the overall vibration level in the fan pulley side bearing was at a level between 10-15 mm/s, a systematic increase was observed in the vertical axis which reached up to the levels of 20-25 mm/s.*

An increase in overall vibration levels (OVL, mm/s) along the vertical axis of the equipment was observed. This prompted an evaluation of potential causes, including shaft oscillation or bending due to diameter loss, bearing wear, and out-of-tolerance gaps within the bearing assemblies.

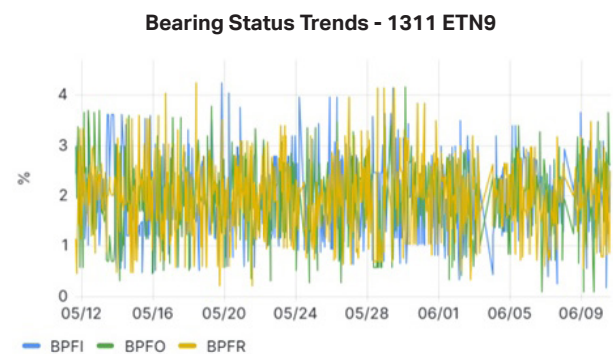
**Fig. 3**

*Lack of an increase in bearing failure trends also supported the idea that there may be runout in the shaft.*

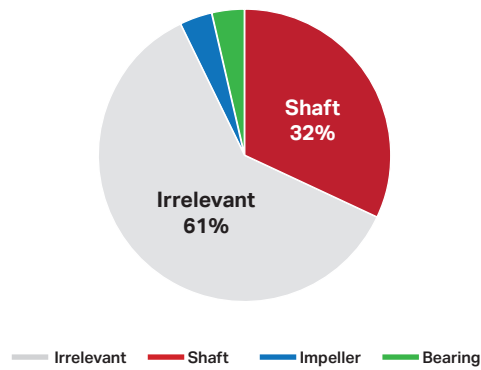
**Fig. 4**

1. No signs of degradation were detected in any bearing subcomponents
2. The ABLE System's component-specific "Vibration Source Analysis" indicated that the dominant vibrations originated from the shaft

*As can be seen from the "Vibration Source Analysis" graph, the distribution rate of the vibration signal is observed to be dominant compared to the bearing and fan blades in the overall distribution.*

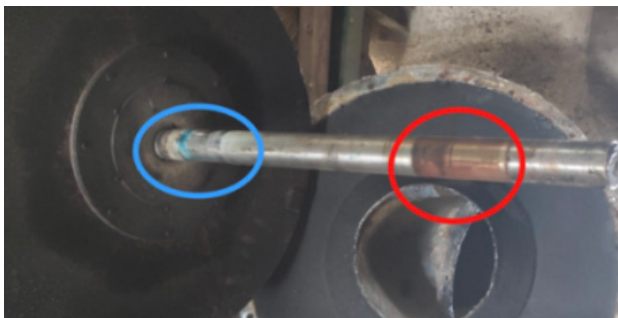
**Fig. 5**

Subsequently, the equipment was taken out of service for maintenance. Post-maintenance inspection confirmed the diagnosis: Shaft wear and runout failure.

*After disassembling the shaft in the equipment that rotates at 3000 rpm, traces of wear caused by runout are seen at two endpoints.*

The pulleys, shaft, and bearings were replaced. Following the replacement, a decrease in the overall vibration level (mm/s) was observed.

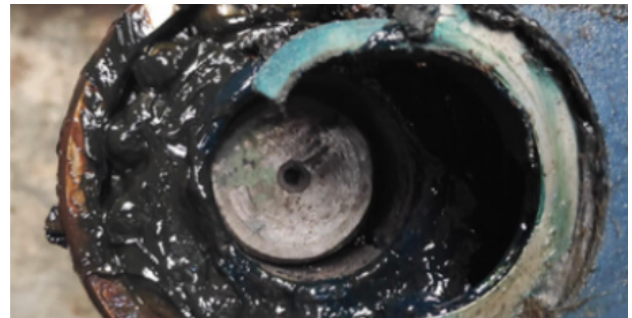
**Fig. 6**

*Due to the shaft runout, the bearing was strained and oil deterioration was observed. After washing and cleaning, no roughness or burring was detected on the rings.*
