In mechanical systems, "soft foot" refers to a condition where a machine's base or foundation is not completely level or flat, causing one or more of its feet to be slightly elevated or out of contact with the surface. This condition can create an uneven load distribution, leading to various issues such as misalignment, vibration, reduced equipment performance, and potential damage to the machine.

In the images below, MDI shares a classic case of soft foot:

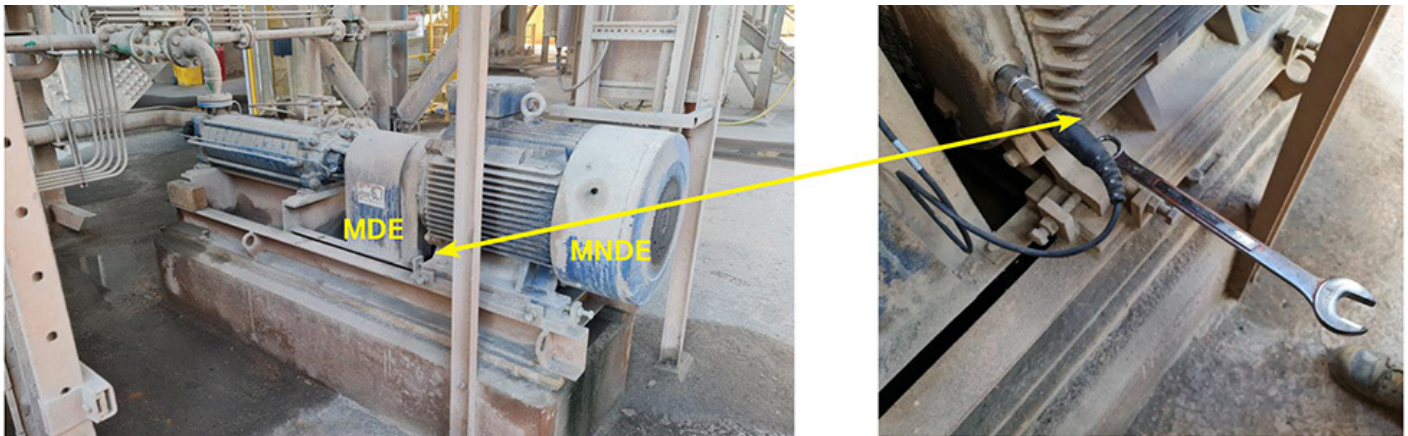
The motor was showing high vibration levels at the second harmonic and twice line frequency at 100 Hz. The customer suspected structural looseness was the problem, so ODS analysis was planned for the motor and pump, in addition to a bump test to check the natural frequency.

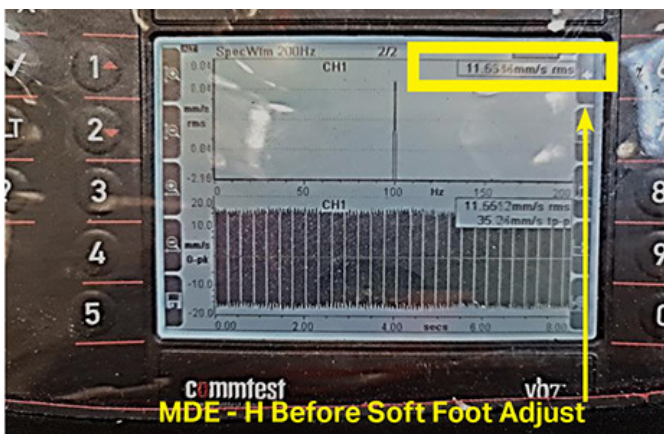
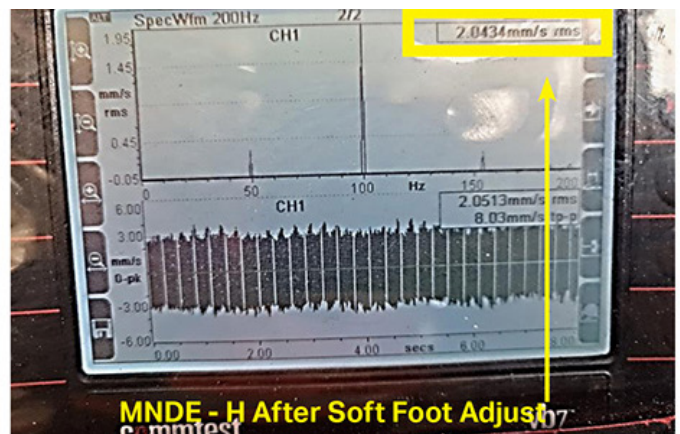
Before starting the job, MDI decided to carry out a soft foot dynamic test. They utilized a CTC AC292 compact, multipurpose accelerometer and magnet mounted it to the bearing housing. The analysis confirmed it was a soft foot fault. After adjustments were made, there was a massive drop in vibration levels from 11.7 mm/s to 1.9 mm/s:
