Introduction

In this case study, Machinery Diagnostics Institute (MDI) was commissioned to address a high vibration issue on a kiln hood fan at a construction plant located in Queensland, Australia. Effective vibration analysis plays a crucial role in identifying such issues before they lead to further damage or unplanned downtime.

Machine Info. Kiln Hood Fan #1

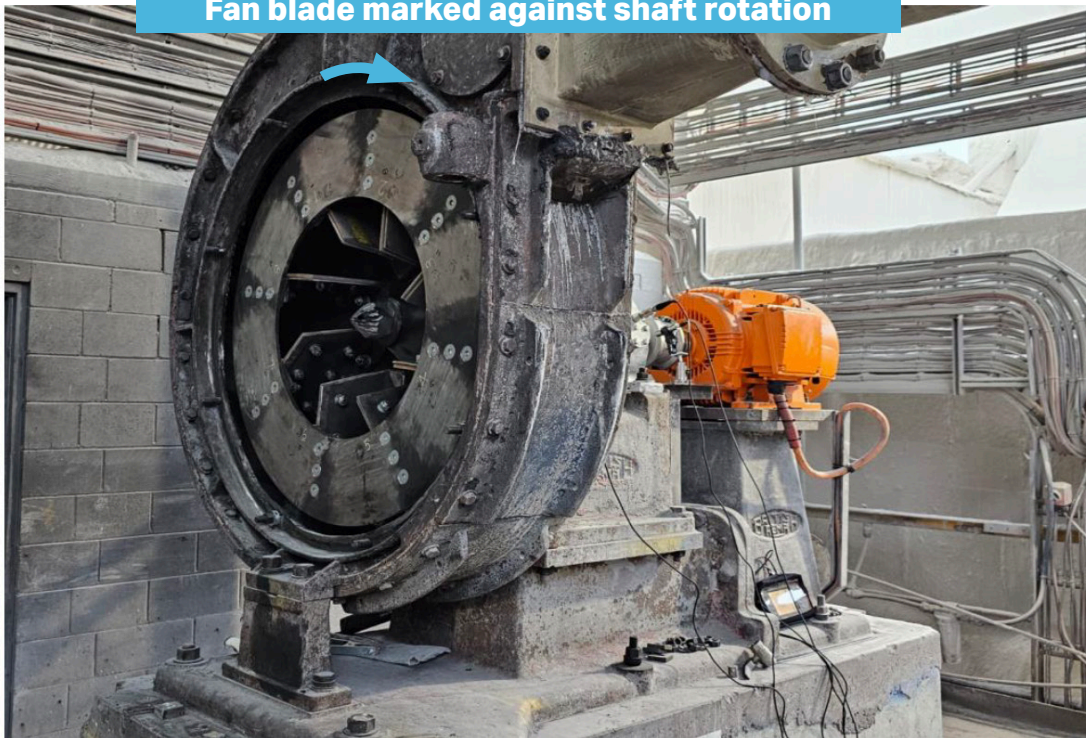
Fan blade marked against shaft rotation
