# Case Study: Vibration Management & Optimization of a 38 MW Steam Turbine

A turbine repair company recently undertook an overhaul and rotor balancing of a 38 MW steam turbine in Queensland, Australia. Post-overhaul, the client engaged Machinery Consultation and Service Pty Ltd (MCS Pty Ltd) to perform a comprehensive vibration assessment on the entire machine.

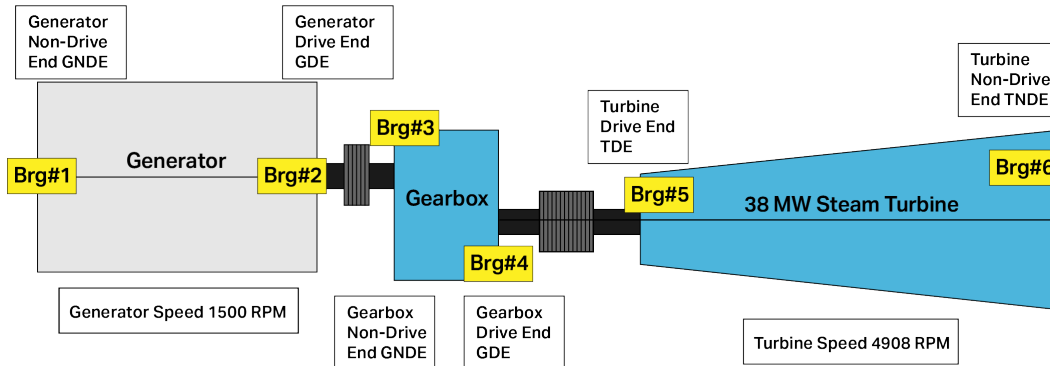
The following diagram depicts the layout of the 38 MW steam turbine:

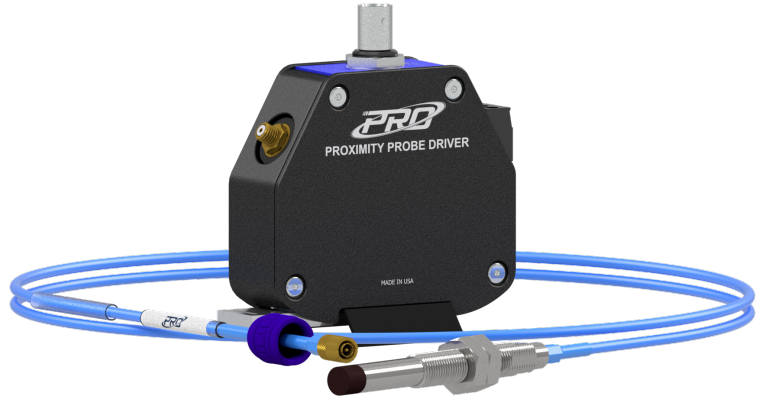
A PRO Line 8 mm Dynamic Voltage Probe System was the perfect selection for this application. Probes utilized in speed/phase applications should be mounted over the portion of the shaft that has one or more keyways in its rotation path. PRO Proximity Probes used in this manner will produce once-per-revolution pulse or multiple event-per-revolution pulses from a rotating shaft or gear. The PRO Proximity Probe System provides data that can be used to trigger a device that generates a digital pulse signal.

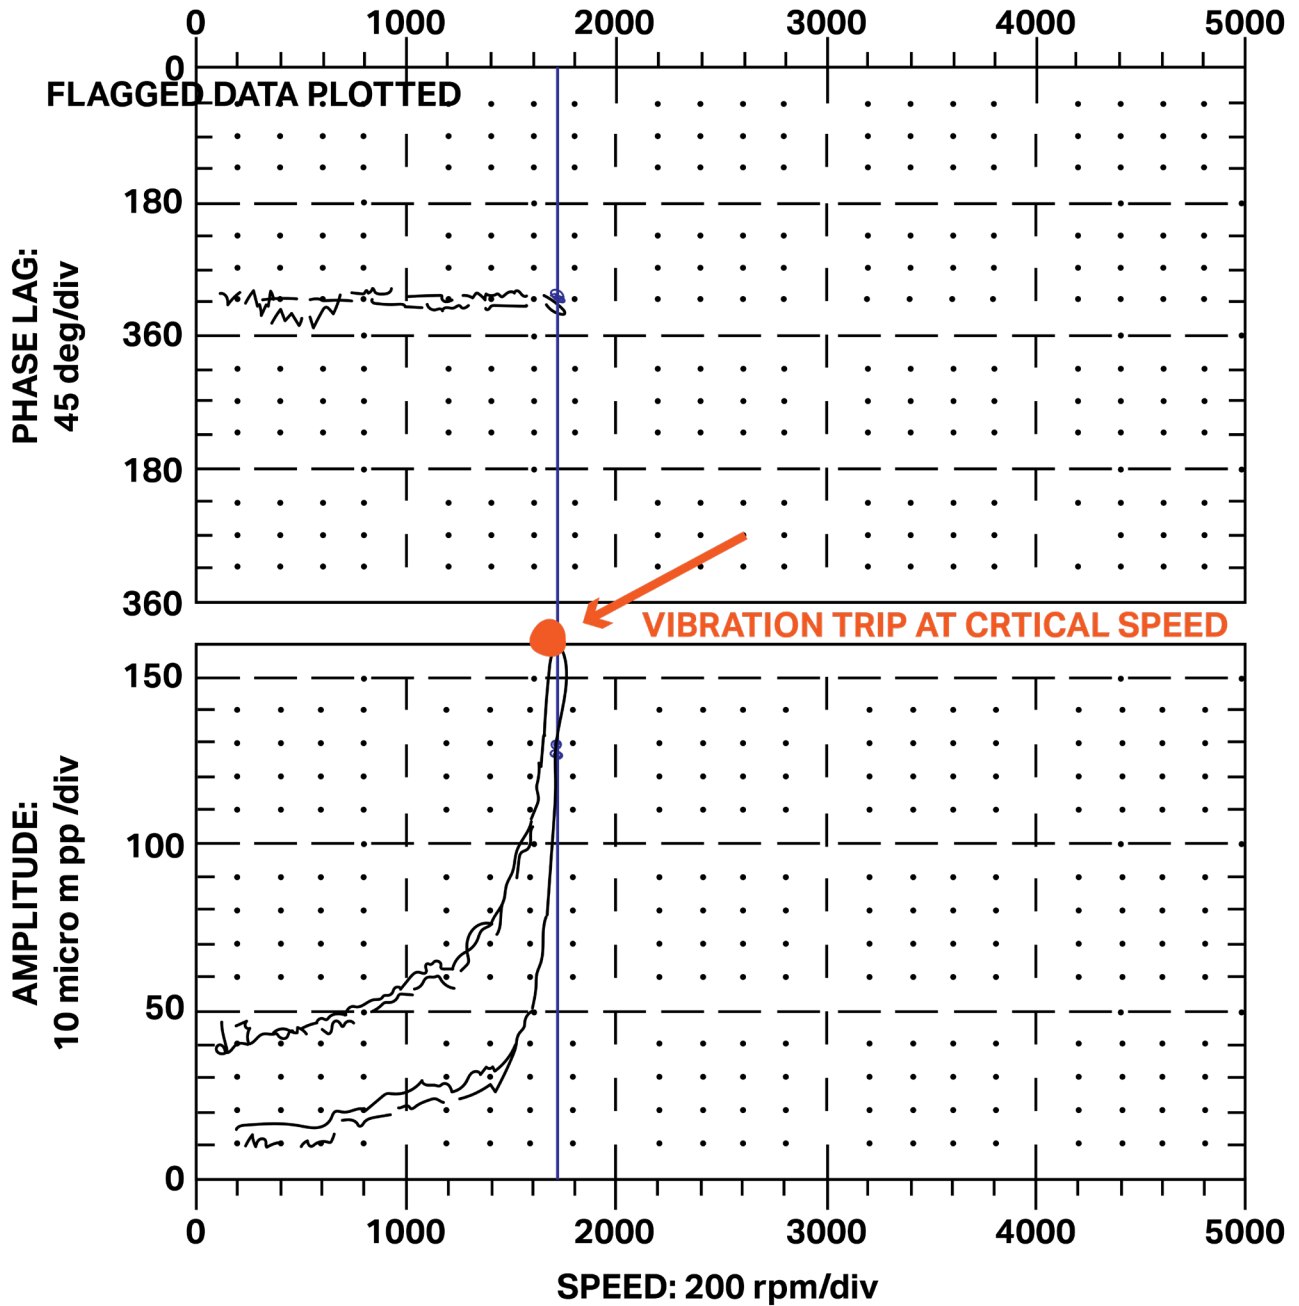
Bode Plot TDE

Tripped due to quick start - Levels up at 156  $\mu\text{m}$  pp:

POINT: TDEY  $\angle$  45° Left — DIRECT 128  
POINT: TDEX  $\angle$  45° Right — 1X UNCOMP 125/322°  
MACHINE: TURBINE  
22MAY2024 21:32:06.7 to 22MAY2024 21:48:19.5 Startup 1720 rpm

- 2 **Overspeed test and quick startup**  
For insurance purposes, an overspeed test was conducted, resulting in satisfactory outcomes. However, during a subsequent quick startup, the turbine rotor experienced high vibrations, reaching 156  $\mu\text{m}$  pp while passing the first critical speed, causing another trip.

- 3 **Final optimized run-up sequence**  
MCS Pty Ltd recommended the following sequence:
  - » Operate the turbine at a slow roll speed of 39 rpm for one hour

- » Increase speed to 566 rpm and maintain for 30 minutes
  - » Reach full speed and maintain FSNL for one hour

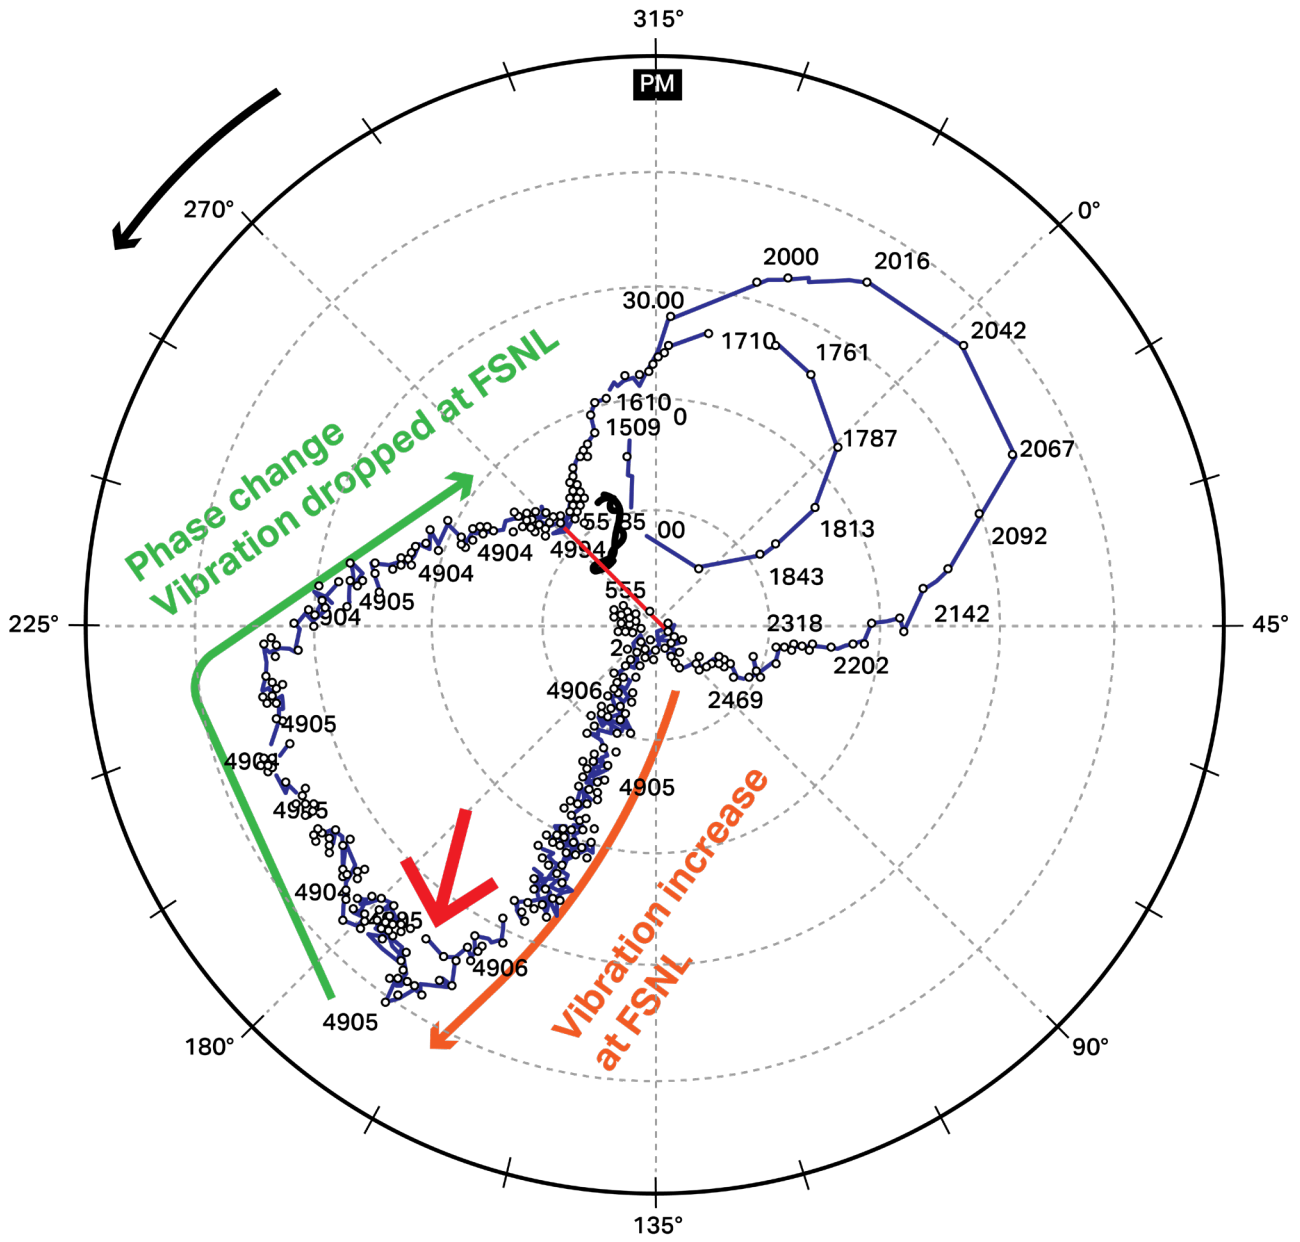
## Polar Plot

For first run-up:

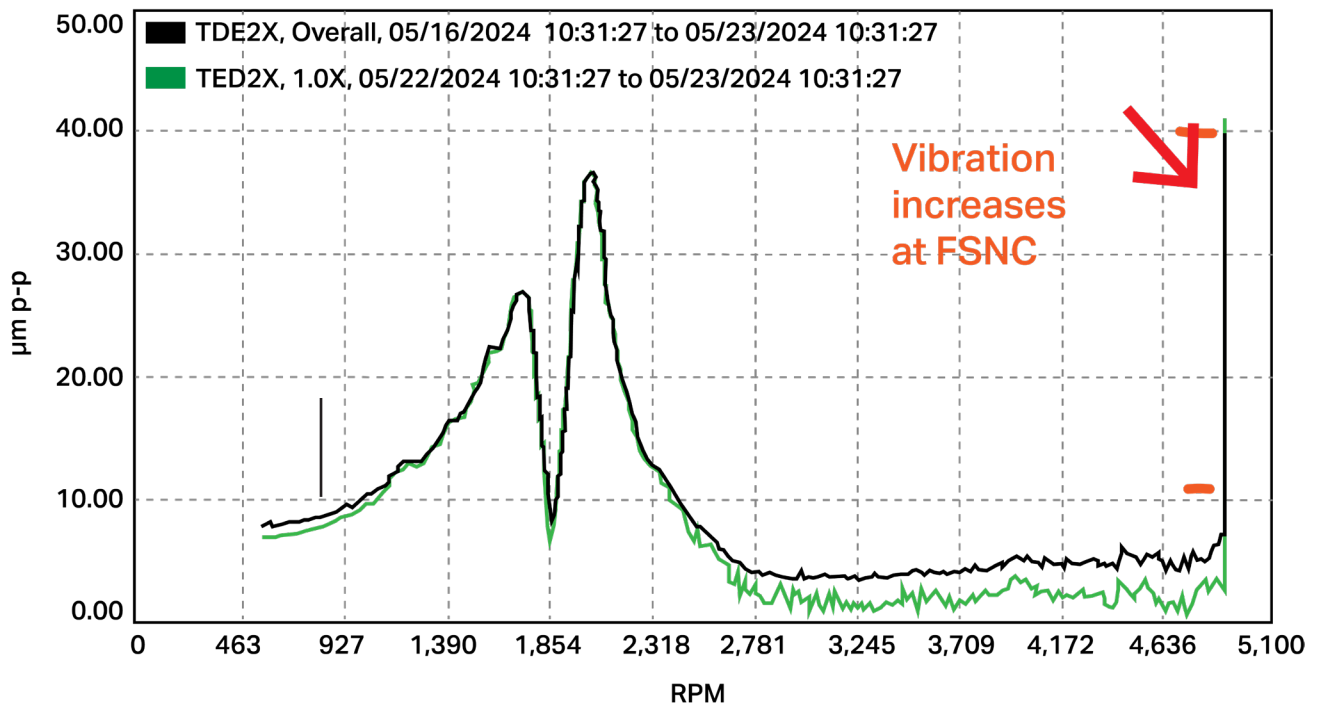
## Bode Plots

For first run-up:
