Introduction

CTC's distribution partners, VKT, were commissioned to perform condition monitoring services at a paper mill in Sweden. VKT elected to pilot CTC Connect Wireless Vibration Monitoring Solutions paired with Viking AI MultiViz software to remotely monitor a critical gearbox.

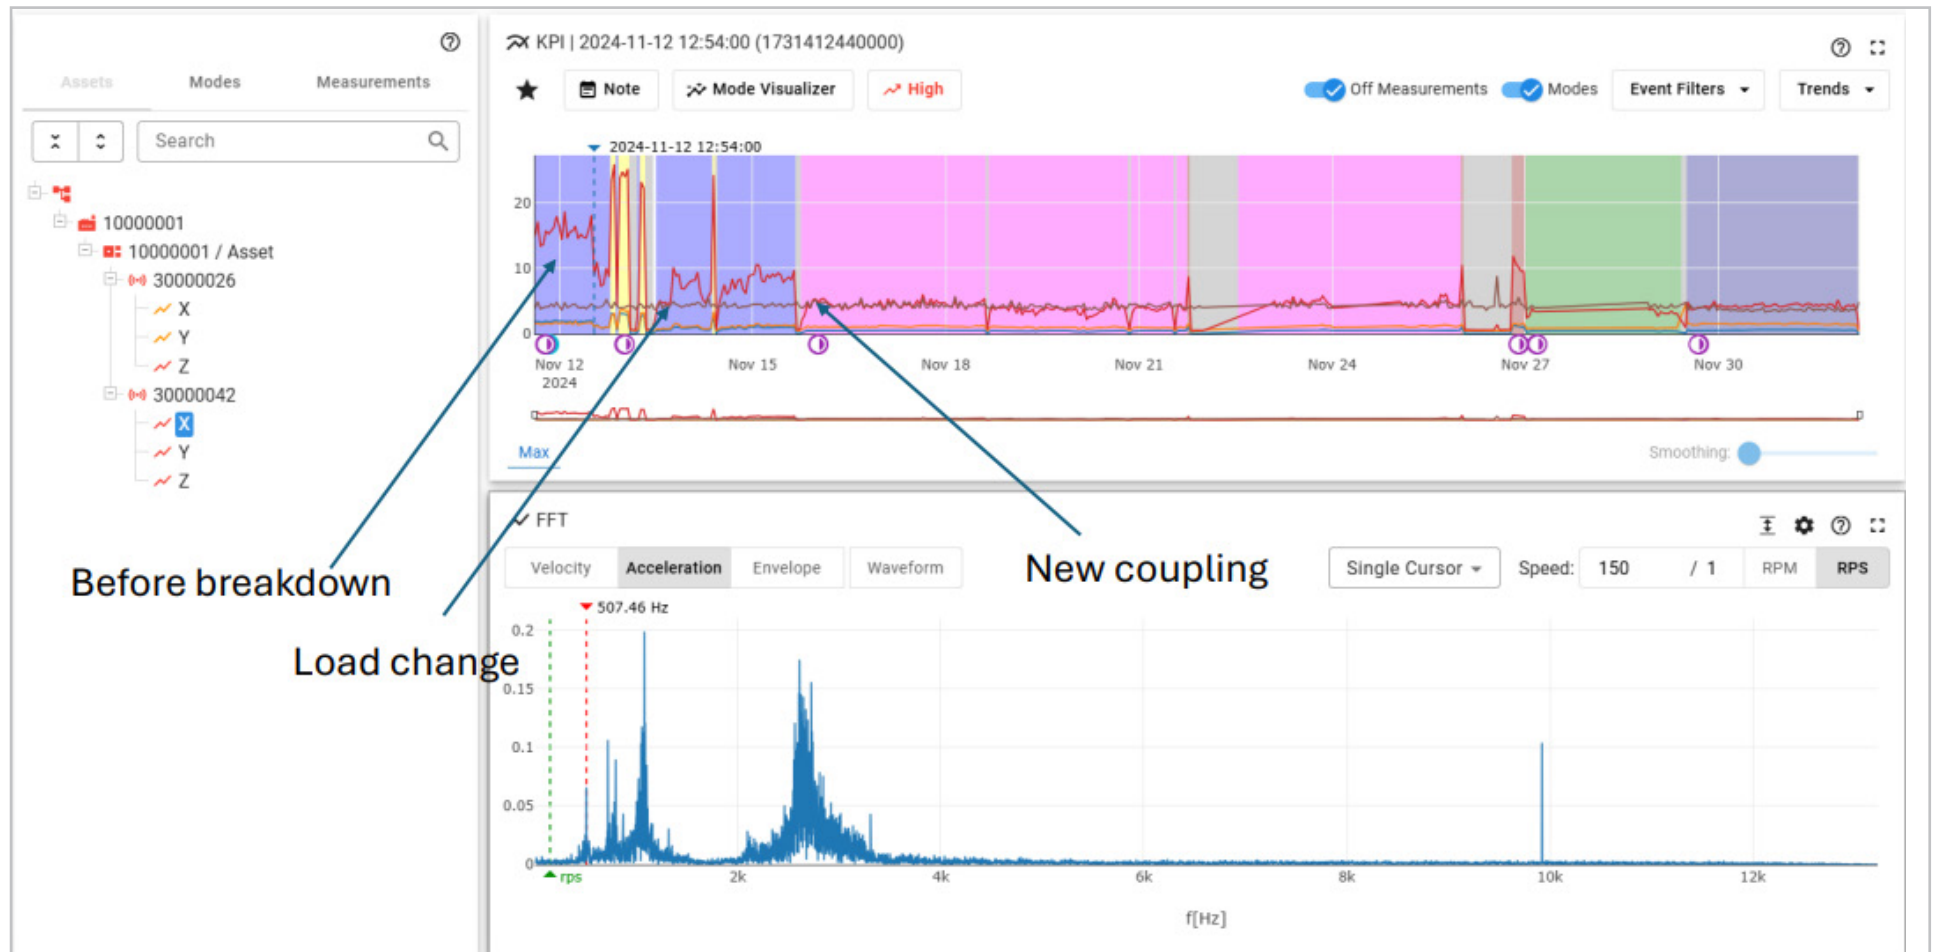
CTC Connect Wireless Hardware paired with Viking AI software was successful in detecting high vibration levels indicating a shaft alignment problem, resulting in damage to the coupling. The detection was automatically done by the software without any manual threshold settings or input of machine information! The **WS301 Series ConnectSens™ Wireless Sensor** presented no issues with prolonged exposure to high temperatures and presented no signs of water ingress from the washdowns.

After VKT warned the plant maintenance team about this issue, the plant elected to continue running the machine for several more days until a shutdown could be planned. VKT advised changing the load while the machine was running, and then ultimately replacing the coupling during shutdown. Once the machine was shut down and the coupling was replaced, visual inspection proved the insights provided by the data collected via CTC Connect Wireless Hardware and analyzed through Viking AI MultiViz Software were correct.
