## Success Story: ASCRIBO + CTC Connect Prevent Bearing Failure in Belt-Driven Fan System

Paper Mill / Belt-Driven Fan System

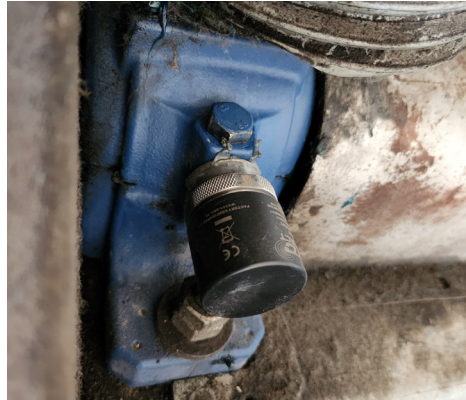
**Fig. 1**

*The bearing housing on the pulley side of the vacuum fan from which vibration data was collected in three axes at 60-minute intervals.*

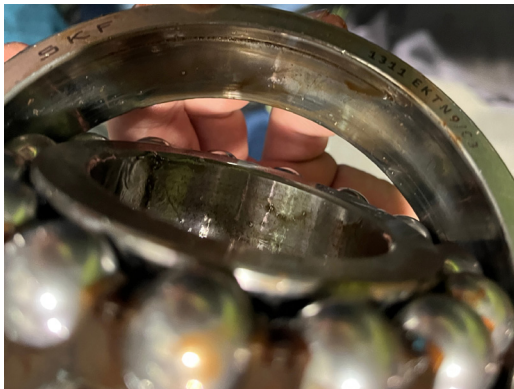
These findings were later confirmed during maintenance:

- Scratches, pits, and distributed defects were found on the outer raceway
- A localized fault was observed on the inner raceway

The fan system was taken offline during a planned shutdown, and the diagnosis was confirmed. The support bearings and fan rotor were replaced and post-maintenance vibration levels dropped below danger thresholds across all axes.
