## Introduction

MDI was commissioned to perform routine data analysis at a Pulverized Coal Mill. Inner race defects were found on two machines:

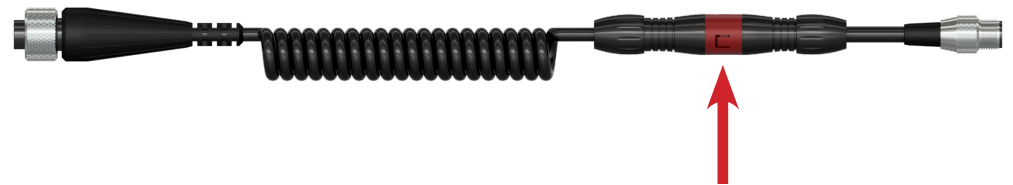
*Utilizing a cable with a breakaway safety feature for portable data collection (as shown here) is extremely important for analyst safety while collecting data on large operating machinery*

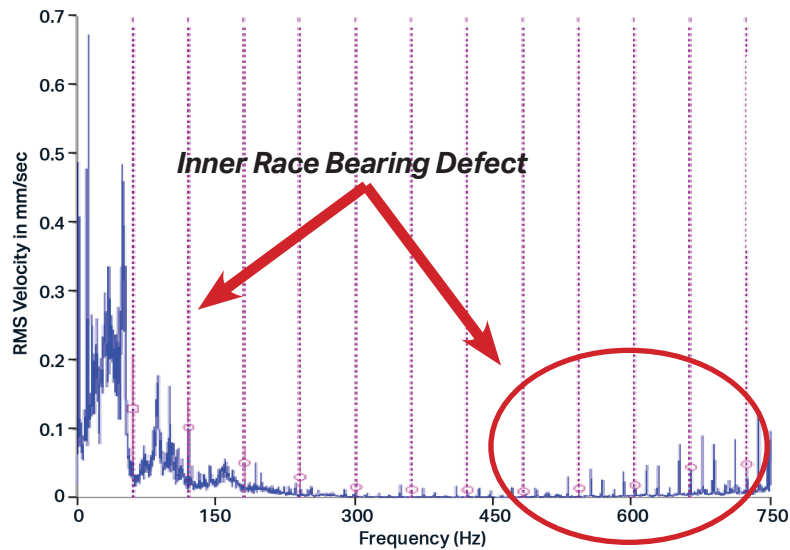
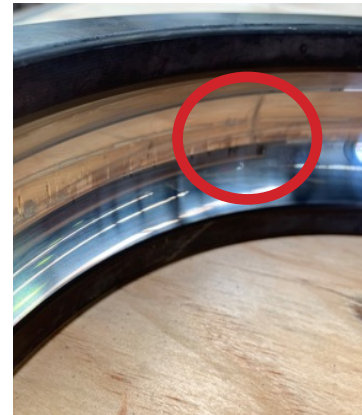
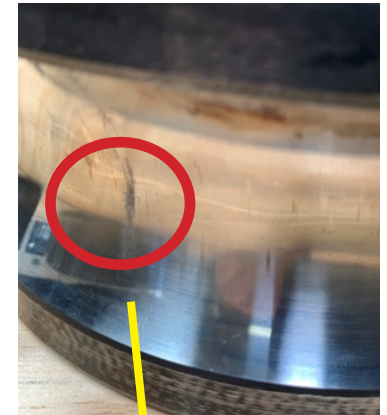
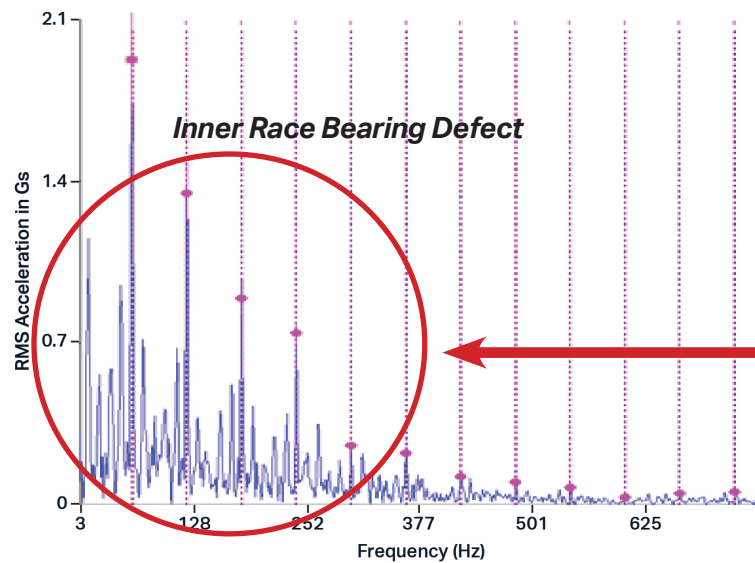
Motor drive end bearing. Velocity and the Peakvue spectrum showed elevated vibration at the inner race defect frequency initiative of bearing fault, the Peakvue trend showed increase on vibration levels up to 2.1 g's

It's essential to note that the frequency range for detecting inner race defects is not fixed and can vary depending on the specific application and the condition of the bearing. In both cases above, it was recommended to replace the bearings showing inner race defects. It was determined that the root cause of the inner race defect in the auxiliary water pump was due to false brinelling.

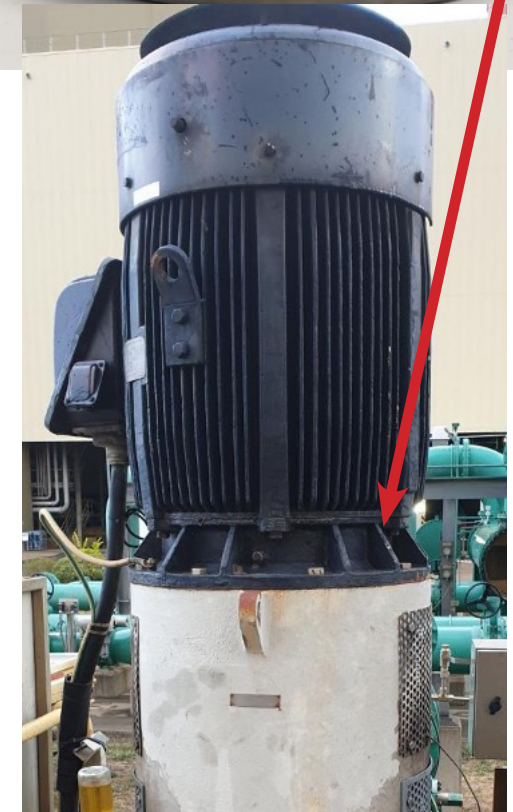
False brinelling is caused by vibrations acting on the bearing while stationary. Since lubricant is not redistributed inside the bearing without rotational movement, lubricant can be pushed out of the loaded region in stationary bearings, resulting in wear and potential oxidation.
