Introduction

Analysis

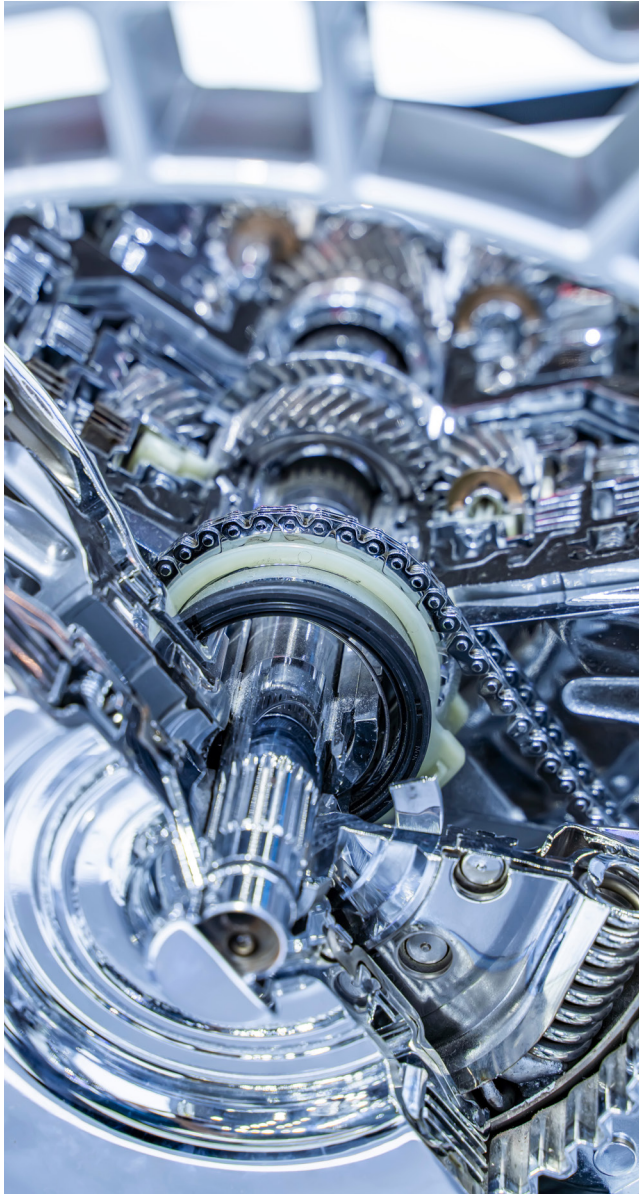
As a result, MDI requested a borescope inspection to confirm the condition of the gearbox. Utilizing a borescope to validate some early warning signs allows technicians to identify defects, wear, or damage in inaccessible spaces without disassembling machinery or structures.

Following the borescope examination, damage consistent with the vibration data was validated as depicted in the photo to the left.
