## Introduction

Large commercial chillers are critical to facility operations, supplying thousands of tons of cooling through extensive piping networks. While the machines themselves are designed for reliability, the surrounding support structures may be more vulnerable. JetTech Mechanical was commissioned to perform routine vibration analysis at Arizona's State Farm Arena. The arena operates six chillers connected to a common chilled water header.

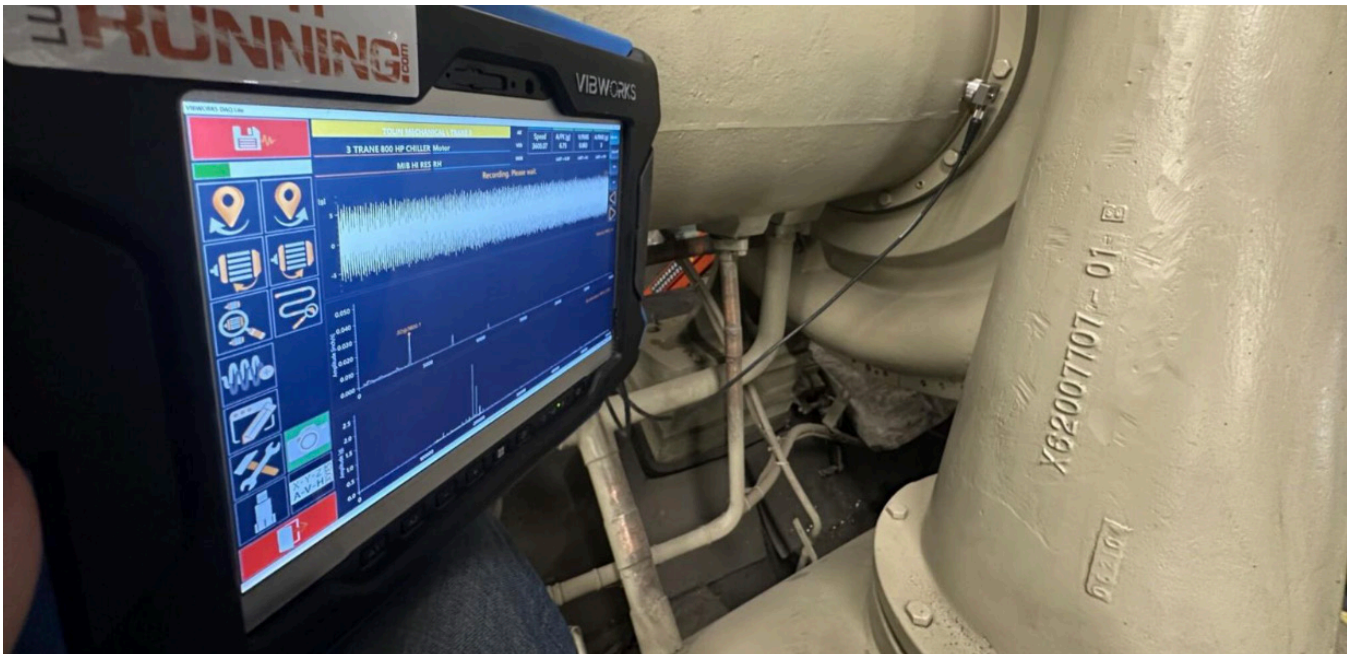
During routine vibration data collection, excessive vibration was detected - not on the chiller, but on the piping support structure. The newest unit, a **Trane 862 kW ( $\approx 1,156$  HP) chiller** operating at **4160 V and 3570 RPM**, was piped into the header alongside the existing chillers. The chilled water lines are supported on H-beam steel mounts. While the supports appeared substantial, vibration monitoring revealed otherwise.

The impact testing confirmed the cause: **structural resonance**. The results showed that the H-beam supports had a natural frequency of **~59 - 60 Hz**, nearly identical to the chiller motor's operating speed of **3570 RPM (59.5 Hz)**.

When the chiller was online, vibration at the top of the support frame reached about **0.7 in/sec peak at 1x running speed**. Amplitudes increased from bottom to top, showing that the structure was resonating in **its first bending mode**.

It was determined that resonance was exciting the piping support structure at the chiller's operating speed. While the chiller itself was unaffected, the facility faced significant structural risk if left uncorrected.
