Introduction

Analysis

MDI was commissioned to perform routine data analysis at a Cement Plant. A gear mesh fault was found on a gearbox.

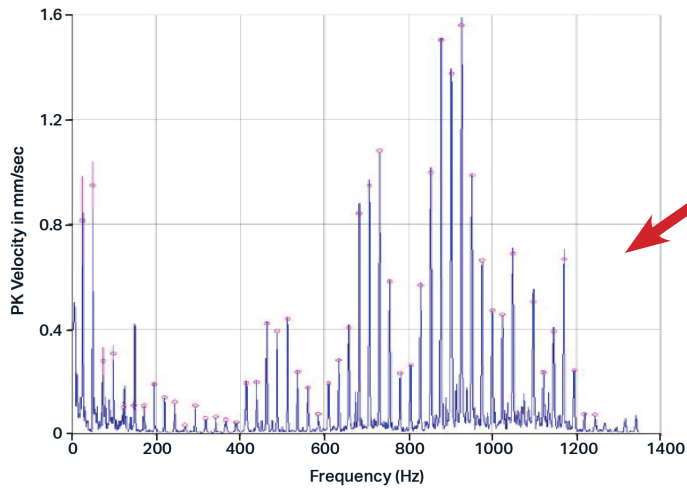
Gearbox bearing spectrum showing elevated vibration at the running speed with harmonics in addition to high amplitude impacting vibration at the time wave form at the running speed indicative of cracked or broken gear teeth

Through routine data collection, MDI was able to see that there was a clear gear mesh fault, which ended up being a chipped tooth. As a result, the recommendation was to replace the gear, prior to failure.
