CTC AppNotes

Viton vs. silicone in Seal tight boots.

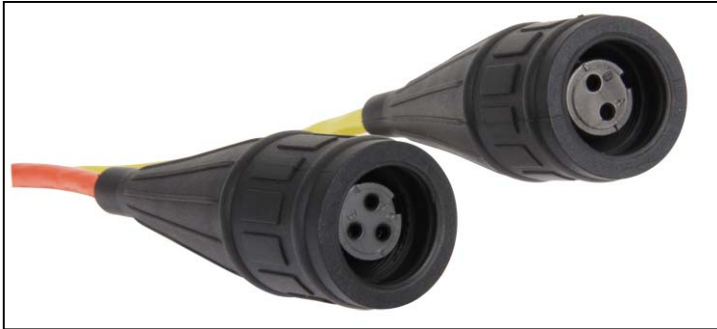
New VITON® Boot offerings from CTC. Enhanced chemical resistance and an IP 68 rating.

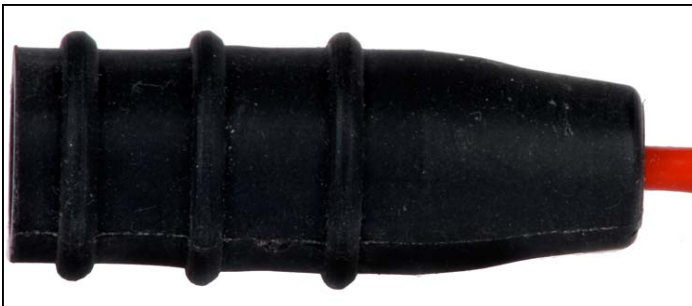
CTC's B2A Silicone seal-tight boot has been used successfully for many years in many environments.

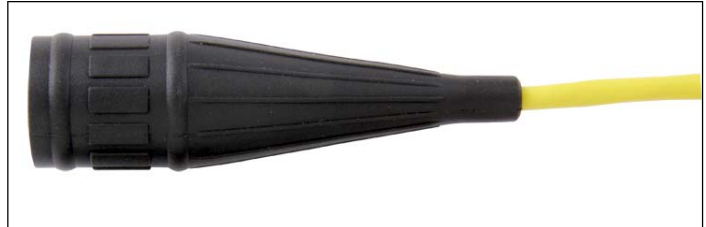
New V2N connector boot shown on CTC's high temperature cable CB111.

boot that will provide superior protection and can even be submerged for extended lengths of time in depths of up to 5 meters without allowing water to penetrate to the sensor connections. The V2N and V3N Connectors have

been tested to the IP 68 standards and passed with no water ingress observed at all.

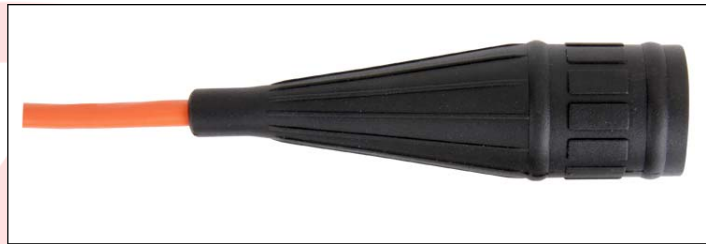
Three socket connector V3N requires CB119 4 conductor cable to maintain the coveted IP68 rating.

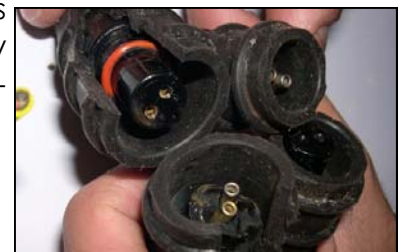
Silicon boots splitting after prolonged exposure to chlorine.

chemicals, like chlorine, can cause silicone to deteriorate rapidly, yet have little or no effect on Viton.
